**State of Louisiana
Coastal Protection and Restoration Authority**

**2018 Operations, Maintenance, and
Monitoring Close-Out Report**

**GIWW (Gulf Intracoastal Waterway) to
Clovelly Hydrologic Restoration (BA-02)**

State Project Number BA-02
Priority Project List 1

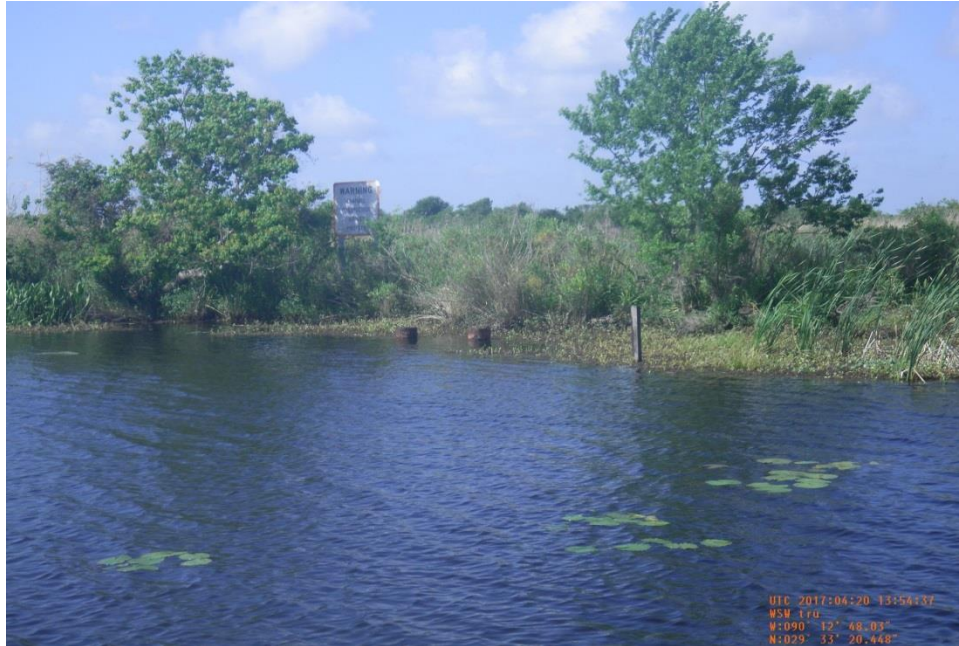
Overall, Structure 91 rock plug appeared to be in good condition. The rock structure was covered with heavy vegetation and woody debris; however, it appears to be in good condition with no obvious settlement or breaches around the structure. The timber piles, the corrugated metal pipe and flap gate were in fair condition and appeared to be operational. There are no plans for maintenance of Structure 91 at this time. (See Appendix A, Photo 34)

Photo No.34 – View of rock plug with flap-gated culvert (Structure 91) along an interior channel.

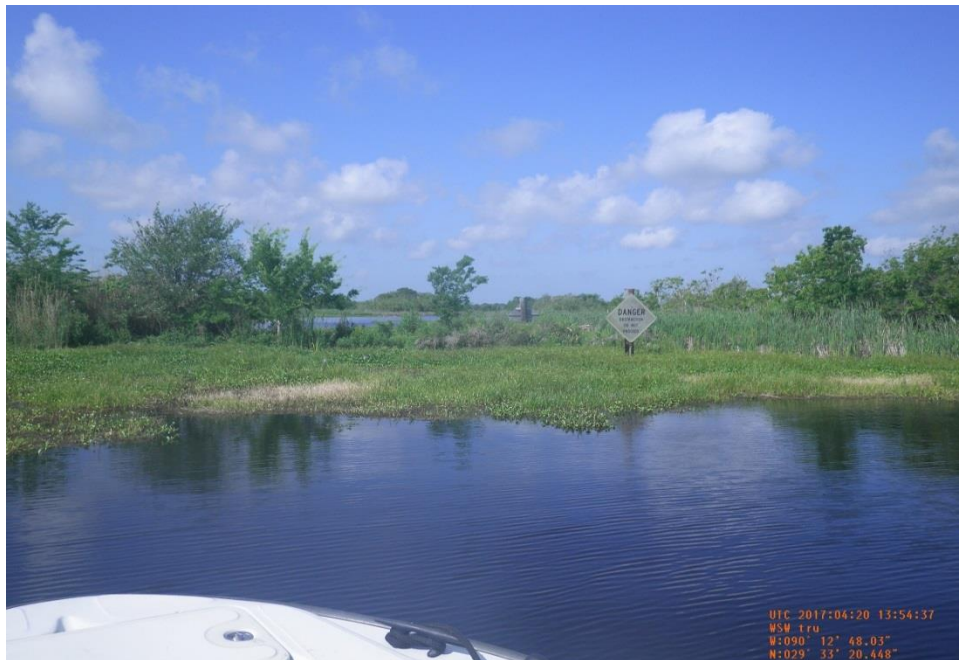
Structure 90 was difficult to access and view due to heavy vegetation on the structure and in the canal leading to the structure. From what we were able to view, the structure appeared to be in good condition with no obvious settlement or breach around the bank tie-ins. The warning signs and supports were also in good condition. There are no recommendations for maintenance of structure 90 at this time. (See Appendix A, Photo 35)

Photo No. 35 – View of rock plug (Structure 90) along interior channel near southern boundary of project.

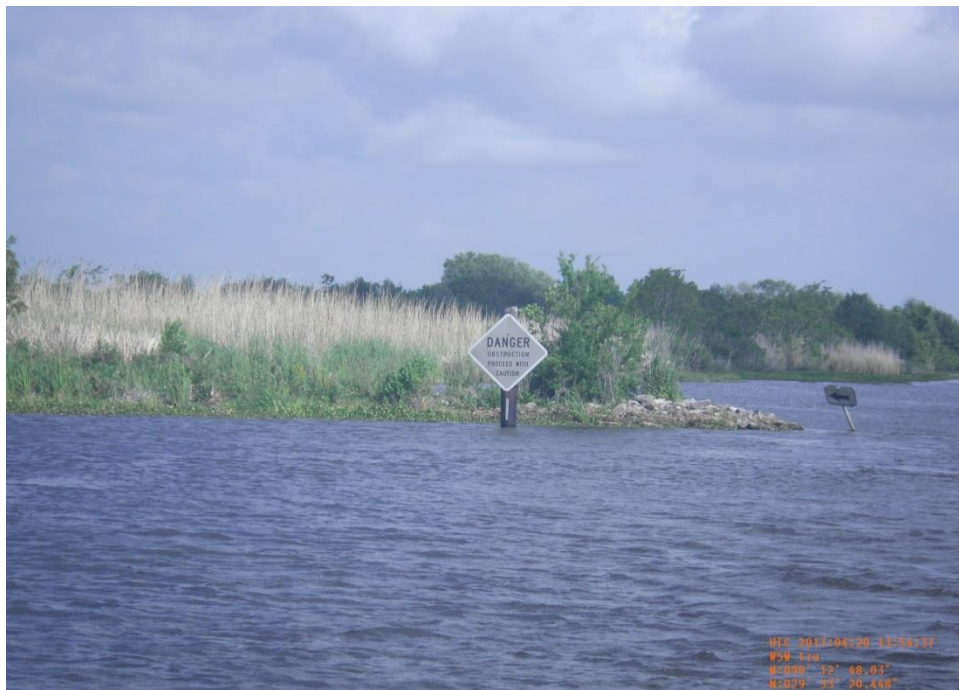
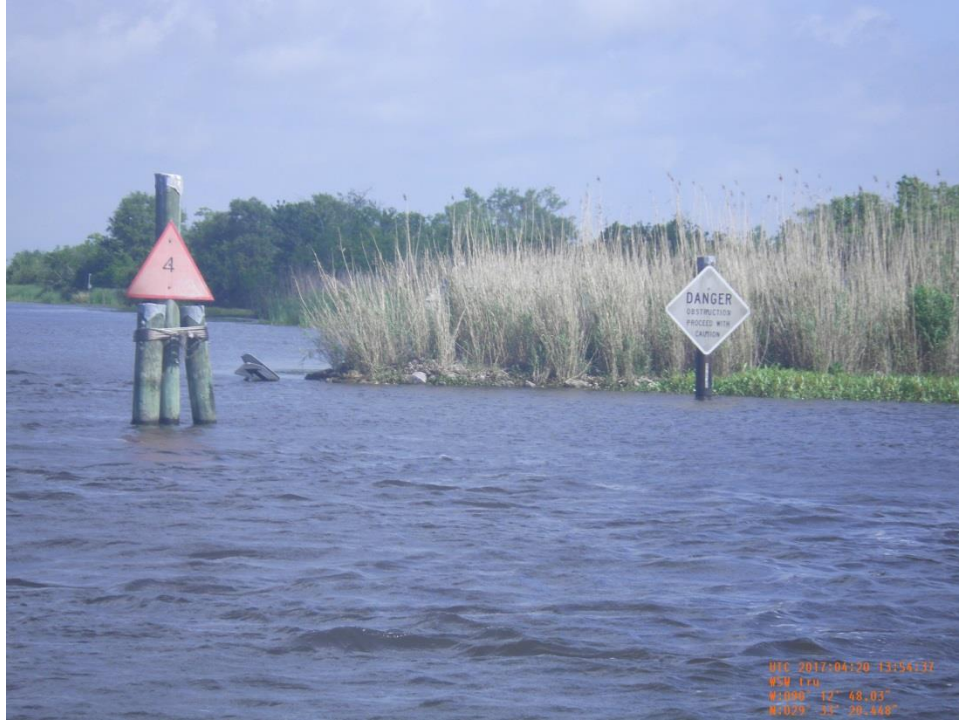
Overall, structure 1 appeared to be in good condition with no visual signs of settlement or damage of the rock structure or erosion along the bank tie-ins. The four (4) timber pile dolphin structures at the entrance of the barge bay opening were replaced in 2012 and are in good condition. (See Appendix A, Photos 36 through 38)

Photo No.37 – View of west side bank tie-in of rock weir at Structure 1.

Photo No.38 – View of east side bank tie-in of rock weir at Structure 1.

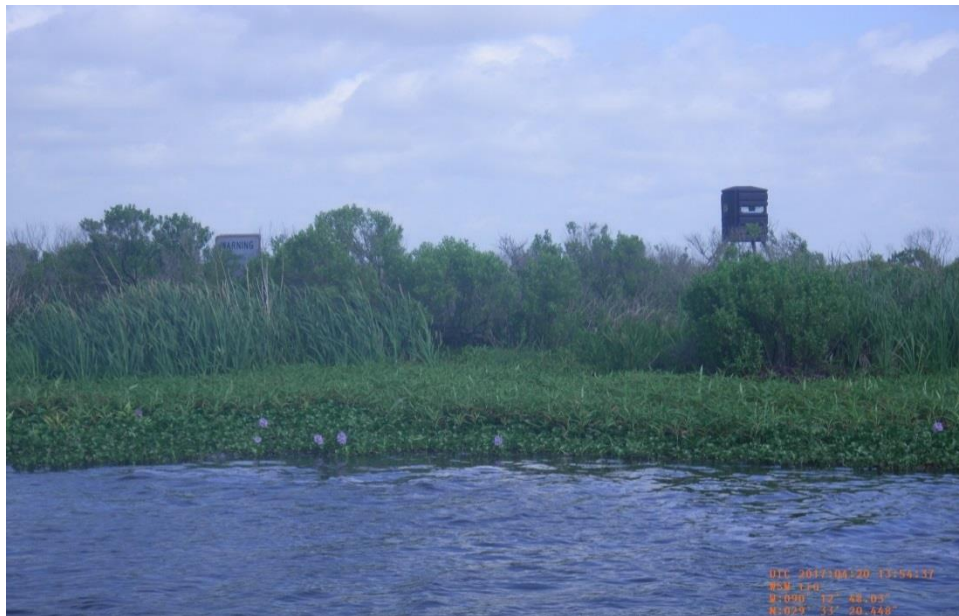
Structure 43 is not visible from the canal due to vegetation and water hyacinth blocking the structure. During past inspections, it was noted that a small opening had developed on the east side of the structure connecting the interior marsh to the canal. We were unable to locate the opening or see any water flow around the structure. All warning signs and support structures appear to be in good condition, and at this time, there are no recommendations for maintenance. (See Appendix A, Photo 39)

Photo No.39 – View of rock plug and warning sign at Structure 43.
